FIELD VISITS in the AMPA for the Regional Transportation Safety Action Plan (RTSAP)

SHOWCASE PROJECTS: INTERSECTIONS AND CORRIDORS

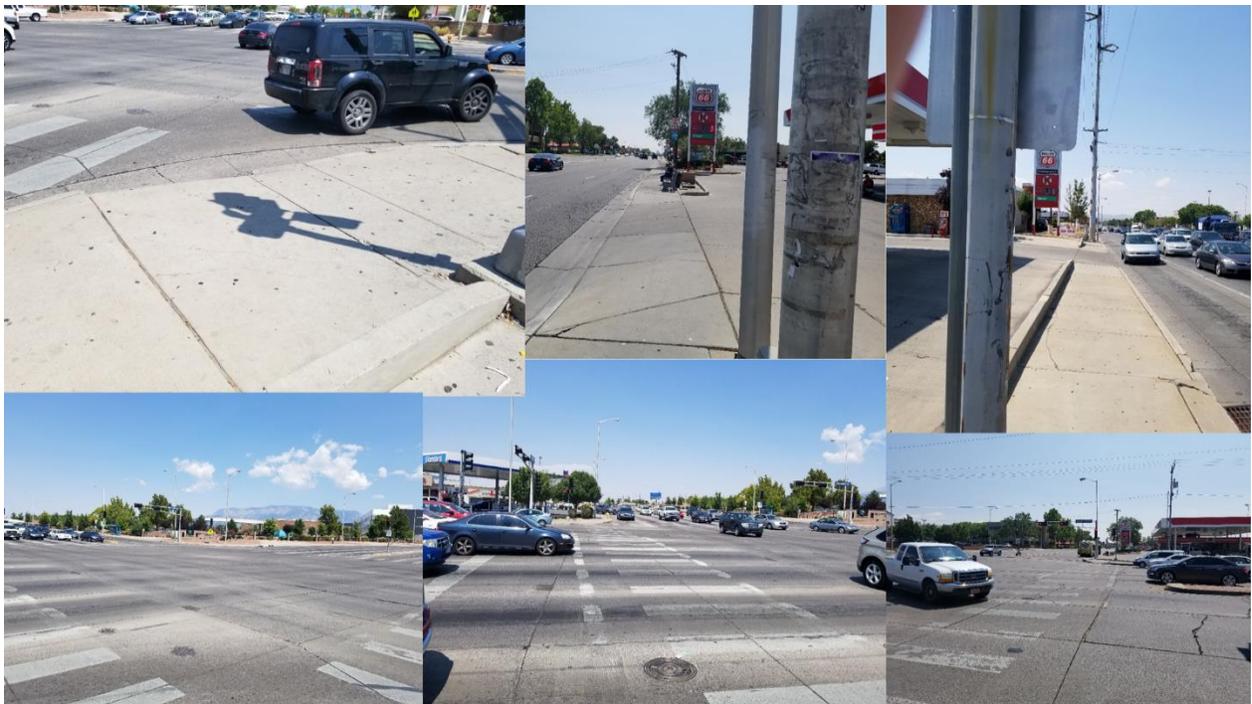
Montgomery & San Mateo

- Heavy traffic demands from all approaches
- Pedestrian facilities are not ADA/PROWAG compliant with no tactile surfaces, sidewalk obstructions, ramp slope issues, and small landing areas to name a few
- There is heavy pedestrian demands with adjacent commercial land use and a High School on the northeast corner
- Many drivers turning right on red ignore crossing pedestrians
- No bus bays at transit stops located on 3 of 4 departure legs
- Closely space driveways are present including a full movement driveway just east of the intersection that limits eastbound left-turn storage capacity
- No bicycle facilities present

- Improve pedestrian facilities to bring into ADA/PROWAG compliance
- Due to the proximity of the school, could look at the feasibility of providing pedestrian bridge (Caution: Many pedestrian bridges are underutilized and require greater costs)
- Introduce leading pedestrian phases to try and minimize right-turn on red conflicts
- Provide bus turnouts at the remaining bus stops
- Review access management for redundant driveways, driveways that could be combined or moved further away from the signalized intersection
- Although available ROW may make pedestrian median refuges infeasible, an investigation into the potential for narrowing lanes could be done to see if median refuges could be constructed and thereby reducing pedestrian crossing lengths
- Consider this as a Showcase Project

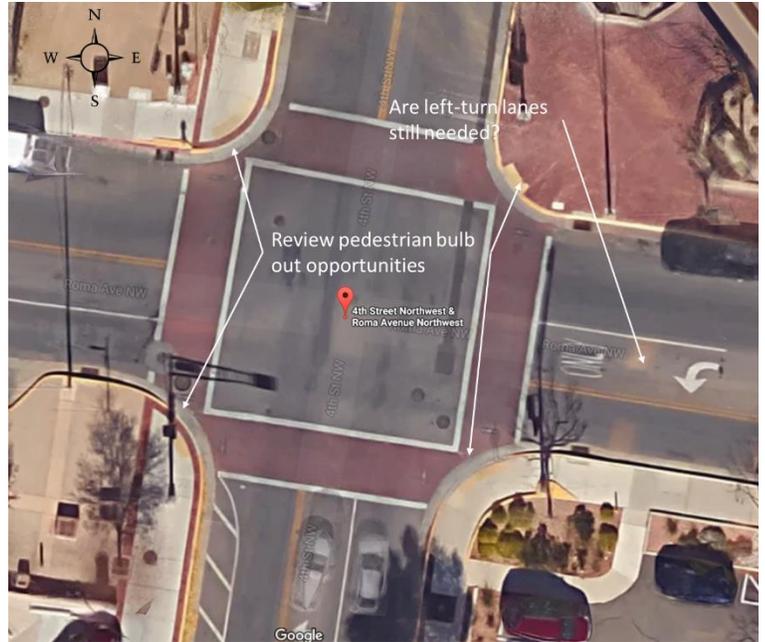
Roma Ave and 4th St

- A large amount of pedestrian and bicycle activity takes place at this intersection because it is located in the central business district
- Original signal control indications have been bagged and the intersection currently operates as a 4-way stop as part of a pilot study
 - This provides smoother traffic flows for all modes in this area
- Crosswalks are red brick making so crosswalk areas more visible to drivers
- Intersection appears to operate well under 4-way stop and provides smoother movement for all modes of travel

- Look at opportunities to add pedestrian bulb outs to reduce pedestrian crossing lengths and improve pedestrian visibility
 - Pedestrian bulb outs are complimented by on-street parking
- Review traffic demands and determine if left-turn lanes are still needed

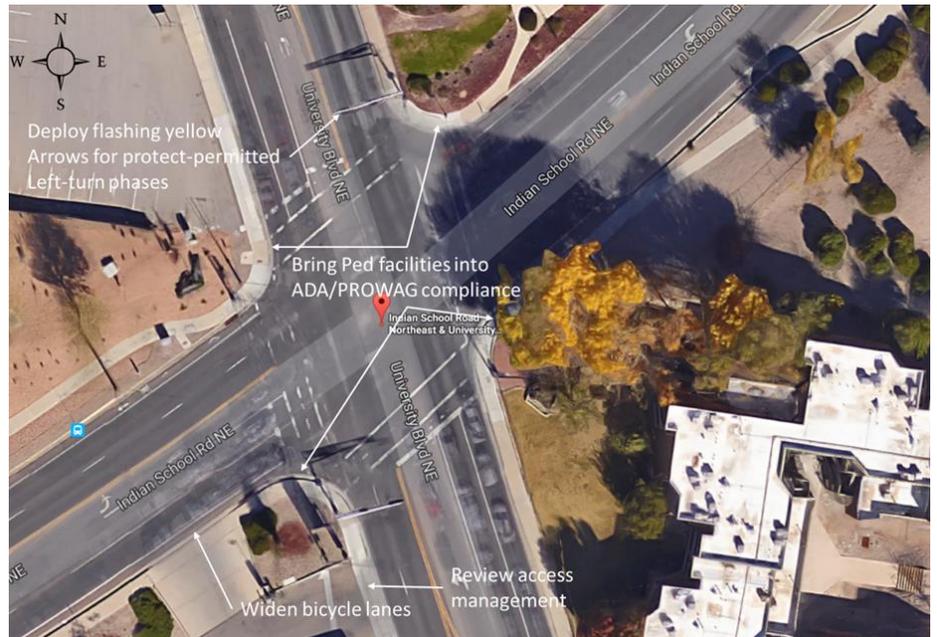
Indian School and University

- Indian school is identified as a bicycle route
- The NE and SW corners are very sweeping and could create more conflicts with right turners and bicyclists
- Bicycle lanes are too narrow for today's standards
- The intersection is not up to ADA/PROWAG standards
- There are some bike buttons available; although they are not identified very well
- Noted permitted left-turn conflicts with pedestrians in crosswalk
- Severe skew present which can reduce sight distance and increase crashes
- Closely spaced access driveways, especially on the west leg disrupts intersection operations

- Since Indian School is a bicycle route, bicycle detection and minimum green adjustment makes sense
- Widen bicycle lanes to current standard width of 5 feet
- Bring sidewalk, ramps and pedestrian buttons up to ADA/PROWAG standards
- Deploy flashing yellow arrows for protected-permitted left-turn phases to eliminate permitted left-turn movements against pedestrians in crosswalks
- Review access management driveways that could be combined or moved further away from the signalized intersection

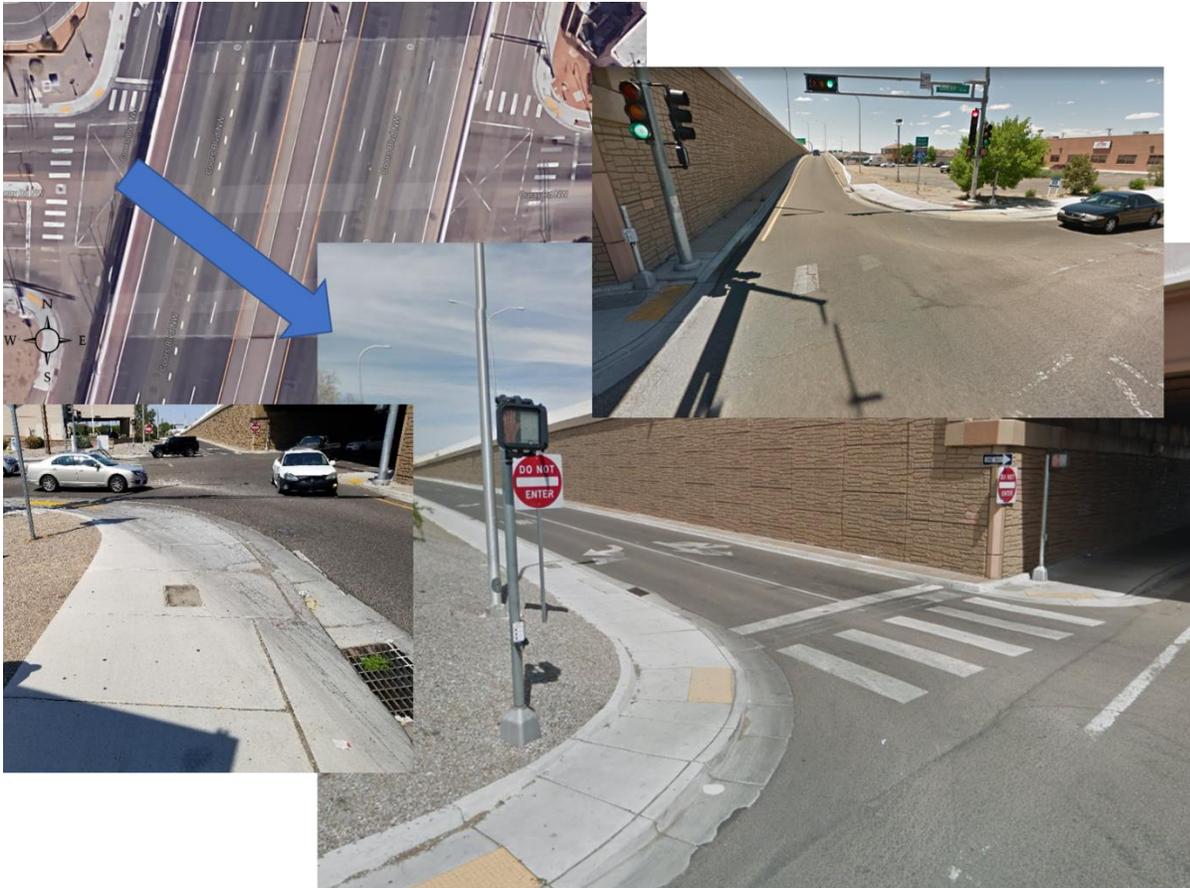
Ouray Rd & Coors West Frontage Rd

- East/West queue issues through either Ouray intersection
- East to North truck paths completely encroach pedestrian ramp and sidewalk
- Lots of red light running westbound
- Opportunity for single controller or communicating controllers for both Ouray intersections
- Visibility between north leg crossing pedestrians and vehicles limited
- The sidewalk on the Southside should be moved and turn widened for trucks turning into on ramp – they literally cannot make it without using the entire sidewalk

- Review signal timing and revise coordination. Also may consider upgrading controller to Cobalt to better coordinate the two adjacent intersections operate as one
- The southeast curb return needs to be reconstructed to accommodate truck turns without requiring the truck to encroach into the pedestrian area
- Could consider installing signal louvers to obstruct the downstream signal indication and minimize the potential for driver confusion

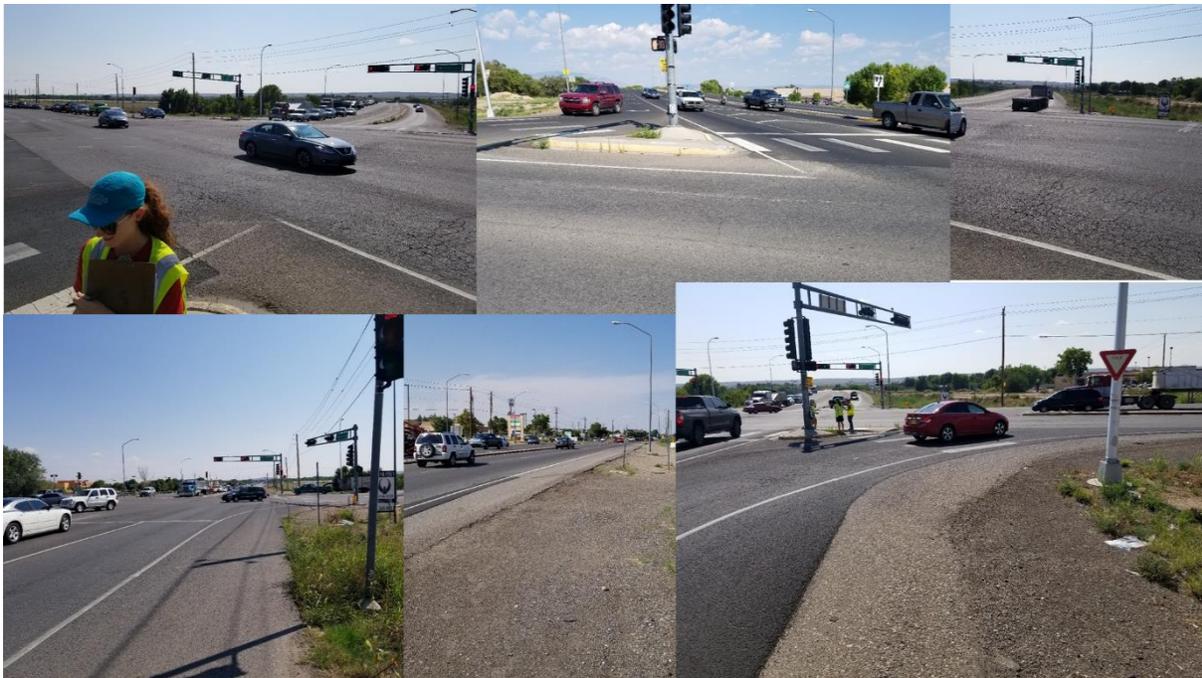
Rio Bravo Blvd & Coors Blvd

- Significant skew at all approaches
- There is minimal pedestrian connectivity and current facilities are not ADA/PROWAG compliant
- It was noted that northbound left-turn queues were backing well into the through lanes
- Very little convenient access to existing transit stops
- Case F sight distance requirements for northbound permitted left-turn lanes may not be satisfied
- Sight distance east-west is also limited by approach grades
- There was a pedestrian button and indication on the north leg but no crosswalk
- No pedestrian warning sign for both channelized right-turns

- Pedestrian facilities that are in compliance with ADA/PROWAG
- Ideally north to west left-turns should go to dual lanes as there is width; however in addition the west departure leg also needs to be reconstructed to receive two lanes
 - Once dual left-turn lanes are constructed this movement would go to protected only mitigating the site distance issue
- Should do an east-west case F sight distance study to make sure appropriate sight distance are provided for east-west permitted left-turns
- Either a crosswalk facilities need to be provided on the north leg or pedestrian signal phasing should be removed
- Pedestrian warning signs and striping should be provided at both channelized right-turns

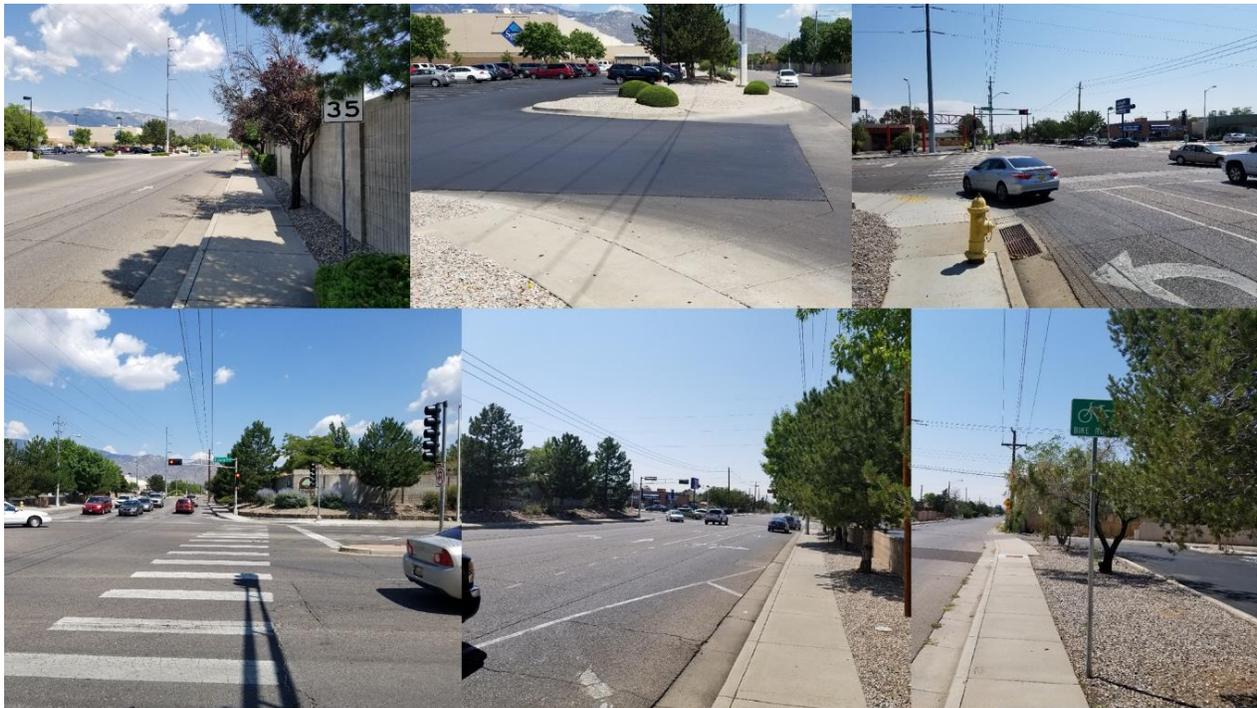
Eubank & Chico

- Pedestrian phase crossing San Mateo felt short
- Vehicles ignored right-turn pocket striping and driving in bicycle lane
- Chico at this location currently is a bike route
- Minimal signage indicating this was observed. Also there was no share the road signs to alert drivers
- There does not appear to be any bicycle detection nor does the minimum green time appear to accommodate a bicycle crossing of Eubank
- Long pedestrian crossing distances across Eubank.
- People speeding/running red lights
- Some low hanging trees potentially obstructing intersection sight lines
- Angled crosswalks lengthen the crossing width considerably/ big intersection
- Full movement access to shopping center on east leg is very close to the intersection, which not only interferes with the operation of the signal but also present cyclist with increase potential vehicle/bicycle conflicts

- Right-turn pocket striping could be enhanced with reflective delineators
- Consideration should be given to keeping the east leg of Chico consistently a bike-shared condition rather than having a bike lane for only 300 feet at the intersection, especially considering a shared condition also exists on the west departure leg as well

- “Share the Road” signs and “sharrow” striping should be added to Chico Road
- Considering that Chico Rd is a bicycle route, bicycle detection should be in place on the Chico Rd approaches

- Both north and south legs on Eubank have additional lane width currently not used as left-turns
 - These areas could be opportunities to install raised pedestrian median refuges with pedestrian buttons shortening the long pedestrian crossing length

- Trim trees along Chico Rd to maximize sight lines
- An access management study should be completed to review appropriate driveway spacing and driveway movements

- Review pedestrian crossing lengths and adjust “Walk” and “Flashing Don’t Walk” times per 2009 MUTCD or later
- Right-turn pocket striping could be enhanced with reflective delineators

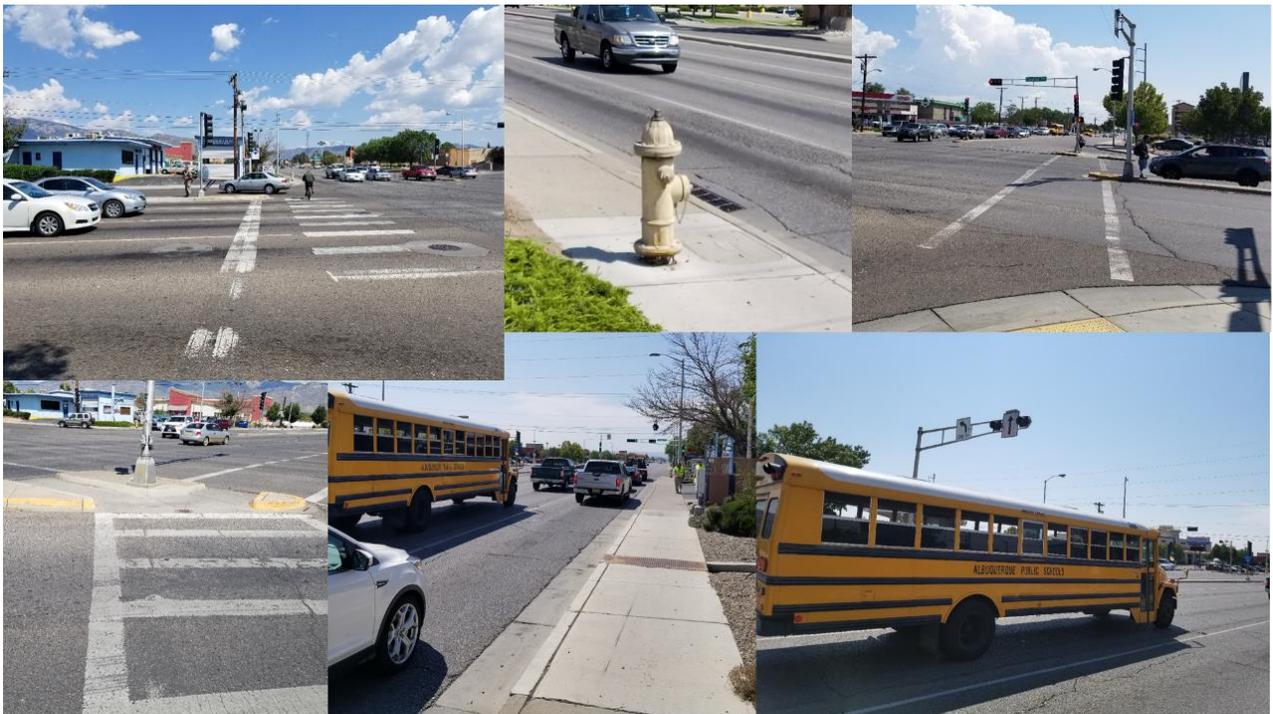
Eubank & Central

- Quite a lot of people walking as well as people on bikes
- Intersection corners are not ADA/PROWAG compliant (ie. accessible button and sidewalk obstructions, and some tactile surfaces missing on south corners)
- Speeds in excess of 50 mph were observed in the field
- Central pavement in poor condition
- Some ped crossing phase times felt short
- Many pedestrians were observed not crossing at the intersection but just upstream/downstream
- SW corner pedestrian indication was obstructed
- There are transit stops on all four departure legs of the intersection with no bus turnout
- West leg median nose obstructs crosswalk path

- Upgrade pedestrian facilities to bring into ADA/PROWAG compliance
- Flashing yellow arrows could be deployed on protected-permitted approaches to eliminate pedestrian-permitted left-turn vehicles

- The potential for providing pedestrian refuges on all approaches should be looked at
 - Potential limiting factors are available ROW
 - The feasibility to narrow vehicle lanes could be looked at to provide additional median refuge width

- Although it looks rather sharp now, the east to south channelize right-turn should be studied to determine if it could be sharpened to encourage slower right-turn speeds and reduce pedestrian crash risks

- An effort should be made to relocate obstructions out of the sidewalks
 - These include bus-stop structures and benches, newspaper vending machines, poles and controllers to name a few

- Consideration to employing bus-turnouts at transit stops might reduce the potential for sideswipe crashes and increase capacity

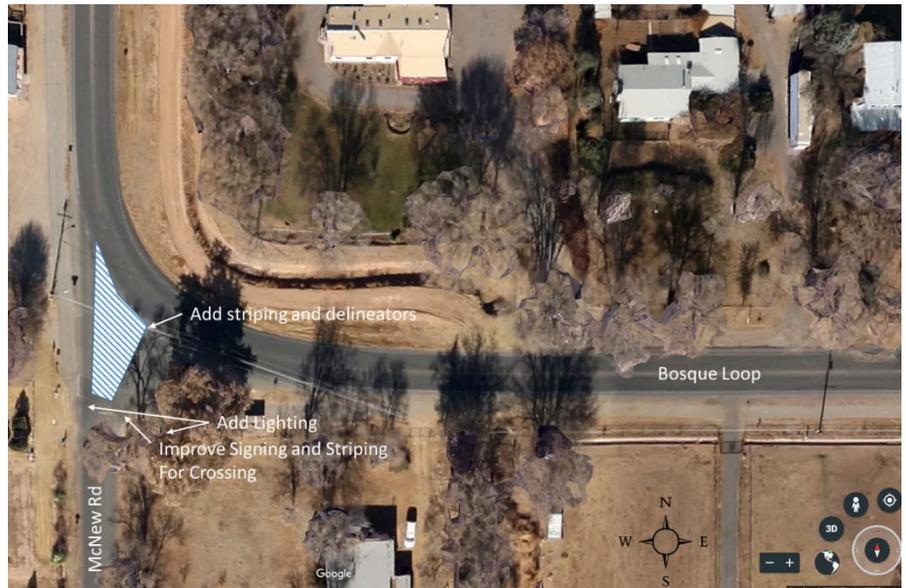
Bosque Loop and McNew Road

- Well used multiuse path
- No Signage or Striping for Multi-Use Path Crossing
- Poorly Lit Especially at Crossing
- No Definition of appropriate turning movements
- Large un marked pavement width is present confusing desired vehicle pathing and encouraging high-speed SB vehicles
- Stop sign on McNew hard to see
- Resident saw near miss crash with bicycles

- Could use Painted or Reflective Object Markers Reducing Drivable Area
- Eliminate high speed direct SB movement from Bosque Loop to McNew Road
- No Definition of Appropriate Turning Movements
- Large un marked pavement width is present confusing desired vehicle pathing and encouraging high-speed SB vehicles
- Move or clear foliage so stop sign on McNew can be seen

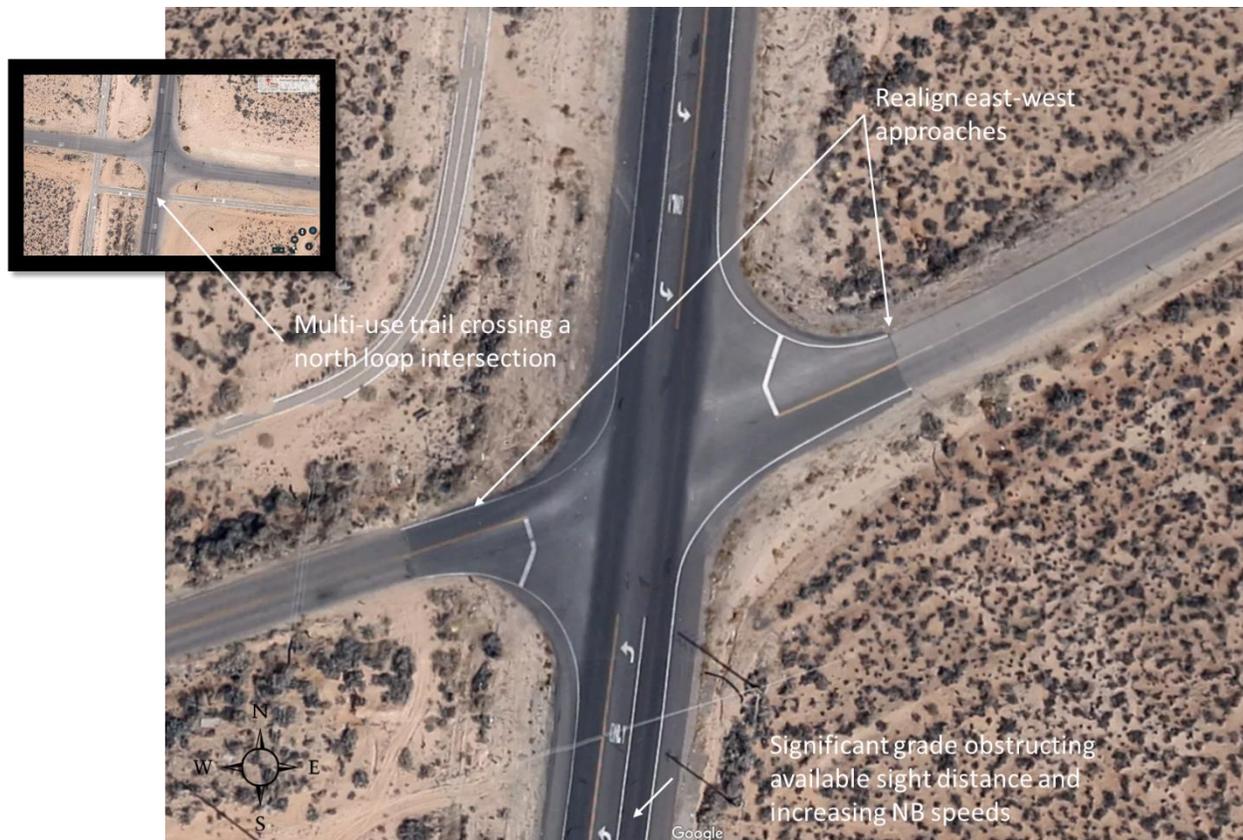
S. Rio del Oro Loop and Manzano Expressway

- Although not part of this field study a multiuse path crossing Manzano Expressway at the north loop intersection has no warning striping or signage
- Rumble strips are present to alert traffic that an intersection is approaching
- Approaches to this intersection are significantly skewed which tends to increase crash risks.
- Seems to be speed is the major factor here – going over a hill and potentially losing control
- Skid marks going west bound – perhaps stopping quickly because they don't see speeding cars coming over the hill
- Car debris by utility road as it approaches the roadway
- Two crosses indicating a fatal crash located north of the intersection.
- Sight distance/ limited sight distance NB with very little warning signage for upcoming intersection

- Add warning signing and striping for multi-use trail crossing at north Loop intersection
- Realign east-west approaches to be perpendicular to Manzano Expressway to improve sight distance
- Provide intersection warning signs for northbound approach to the intersection
- Maybe a good candidate for roundabout control because it reduces speed, mitigates skew, and reduces crash severity

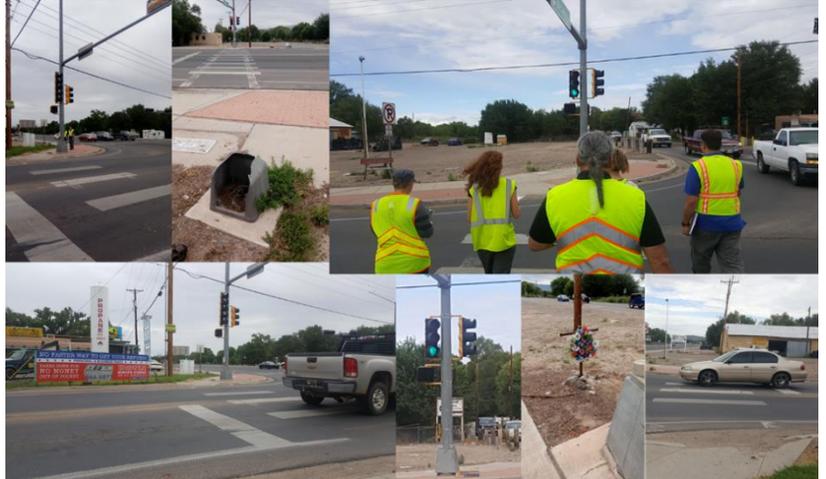
NM 47 and NM 263

- Several pedestrian facility issues including non-ADA/PROWAG compliance, signal indication missing or not working, and crosswalks worn
- Poor line of sight for eastbound approach especially for eastbound right-turns and left-turns.
- Very large curb return radii
- Observed 5 red light runners (2 westbound NM263,1 southbound NM 47, 2 northbound NM47)
- Saw a significant proportion heavy trucks in traffic demands, which probably explains the large curb return radii
- There was a memorial cross indicating fatality on NE corner of the intersection
- Observed many right-turn on red movements not yielding to pedestrians
- No Lighting present at intersection

- Upgrade pedestrian facilities to include more modern crosswalk striping, tactile surfaces, new ramps, and audio/vibro-tactile buttons
- Potential candidate for leading pedestrian interval depending on pedestrian demands
- Sharpen curb return radii while still allowing traversal of trucks
- Review yellow and all-red transitions times and adjust based on clearance distances and the latest practice
- Advance detection on NM 47 to reduce dilemma zone and potential for rear end and angle crashes
- Observed many right-turn on red movements not yielding to pedestrians
- No Lighting present at intersection

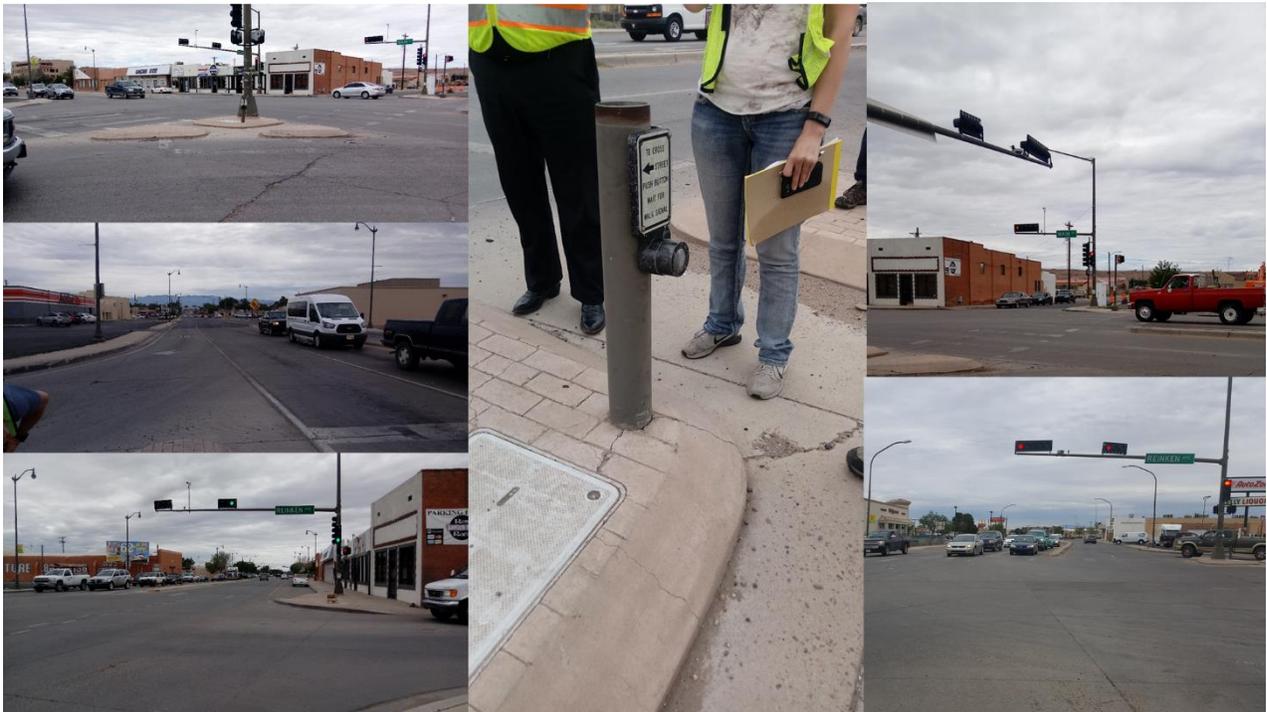
Reinken Ave and Main Street

- Belen has a plan for Main Street to make it into a Complete Street
- West bound left-turn queue backs up into through lane
- One corner sidewalk is bumped out slightly – could tighten curb radii all around
- Current geometry contributes to higher right-turn speeds for the east to north movement and pedestrian crash risk
- No tactile strips
- Pedestrian button on northeast corner does not meet ADA/PROWAG standards
- Poor warning of SB lane drop from through to left-turn
- Possible sight distance obstruction at SW corner, especially for right-turn on red versus pedestrians in crosswalk.
- Case F sight distance issues between NB and SB left-turns - especially impactful to the permitted left-turn phase NB

- The Belen downtown plan, including pedestrian bulb outs and on-street parking should be considered for this intersection
- Access management principals should be applied to all approaches to this intersection

- Consideration should be given to limiting full movement access too near the intersection
 - Removal of the full movement driveway immediately east of the intersection would allow the westbound left-turn storage to extended to accommodate demands

- Look at the feasibility of sharpening curb returns to reduce right-turn speeds
- Sharpen the east to north channelized right-turn to conform to FHWA recommended geometry to reduce speed and pedestrian crash risks

- Bring all intersection corners and sidewalks up to ADA/PROWAG compliance including tactile surfaces, appropriate ramp slopes, button accessibility, current crosswalks etc.

- Study needs to review the need for the additional third southbound lane approaching the intersection.
 - If it is to remain, appropriate warning signing and striping should be put in place to let drivers know of the downstream lane drop condition

- Since removal of skew on SB approach is likely not feasible, the elimination of north to east permitted left-turns should be considered

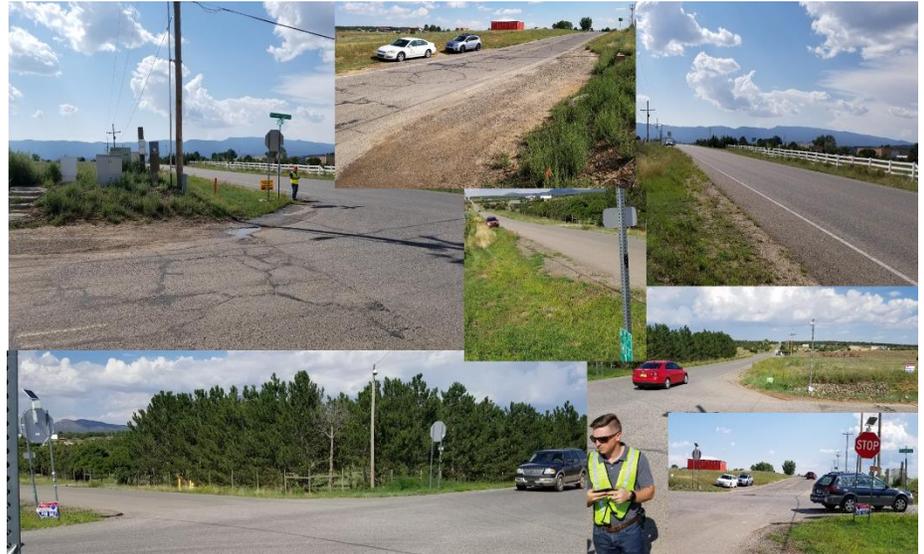
Frost Rd and Mountain Valley

- South bound detectors and flashers on stop sign are not working properly
- This intersection was planned to go to a two-way stop due to 2009 MUTCD requirements for a four-way stop
 - The public was against this removal due to area speeding and the four-way stop remains
- Some line of sight issues with east bound Frost looking north – a lot of utility boxes, etc. (Especially on southwest corner)
- There are grade issues north bound on Mountain Valley that limit sight distance
 - There is an advanced warning sign present indicating a stop sign ahead
- There have been local complaints of speeding on all approaches

- Maintenance needed on stop sign flasher detector
- Since speeding has been identified as an issue by the local populace, roundabout control would be a good fit for this intersection
- Sight distance obstructions should be relocated
- Might consider adding shoulder widths to these roadways on next project to accommodate pedestrians and bicycles

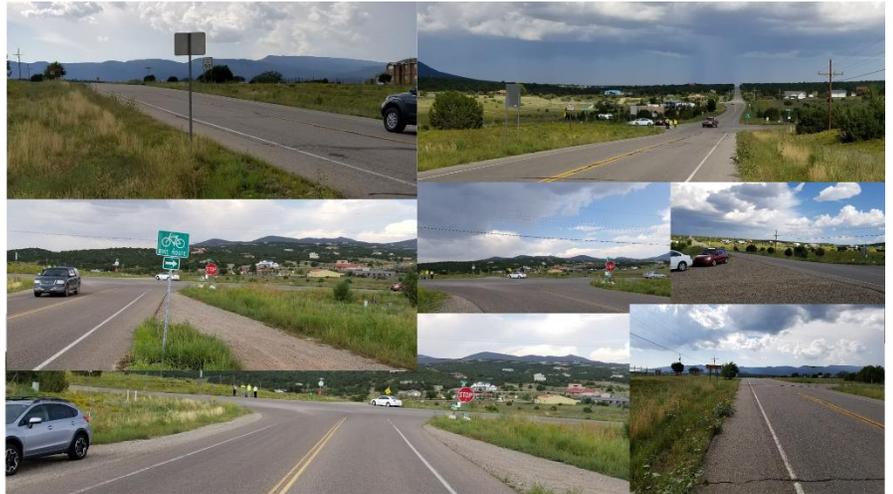
Frost Rd and Vallecitos Rd

- Speeding seems to be an issue on Frost Road
- Speed limits appear to change along Frost Road
- Bike routes are identified on Frost Road, however existing shoulders are narrow and there are no “Share the Road” signs
- No stop line present at south leg stop sign

- With speeding being an issue along Frost, more consistency in speed limits might help with compliance
- Roundabout control is a good mitigation for speeding issues and significantly reduces crash severity
- With bicycle routes identified on Frost Road, an effort should be made to widen paved shoulders
- Add “share the Road” signs on Frost Road
- Could include intersection warning signs on Frost Road

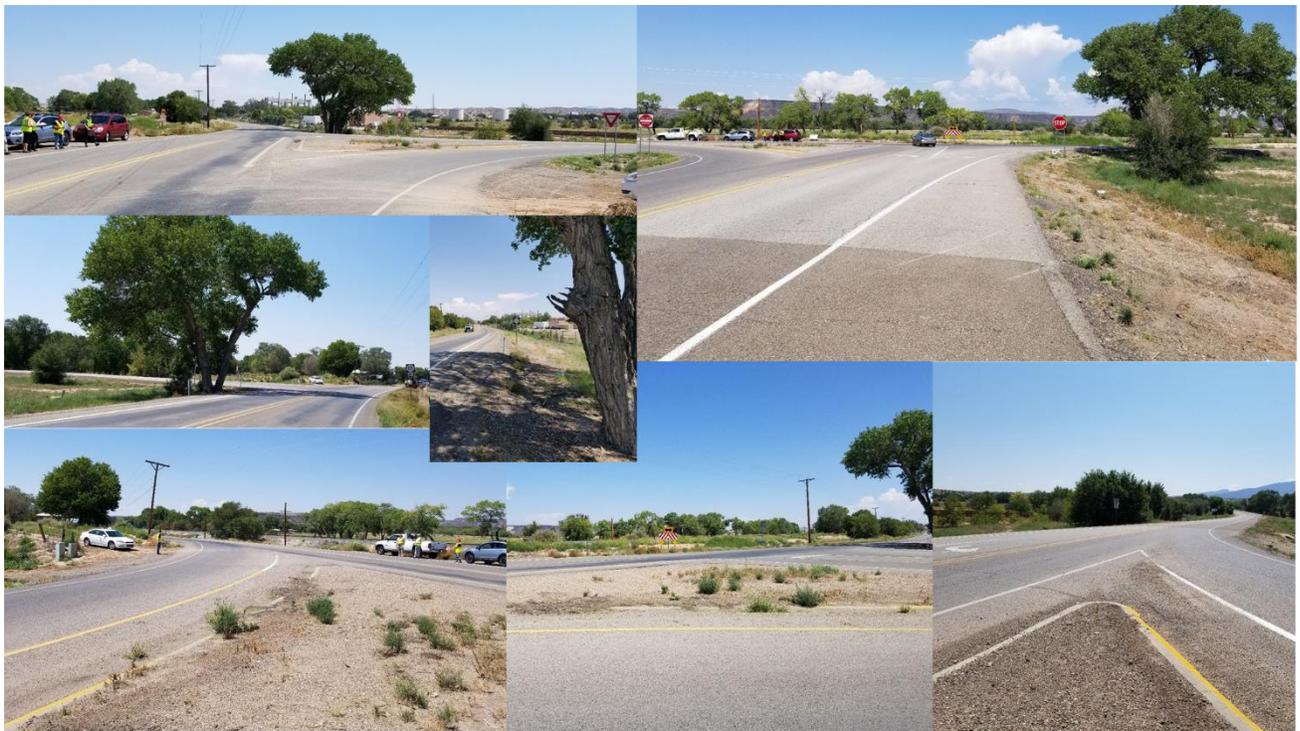
NM 315 and NM 313 San Felipe Pueblo

- No stop bar on north bound right-turn
- Sweeping turns on both sides encouraging higher speeds
- Large channelizing island is difficult to see
- No crossing marks or pedestrian facilities
- Shoulder condition poor for bikes/pedestrians including vegetation in way / poor edge condition and slim shoulder available
- WB left turning movement may cut across stop bar due to the location of the NB left-turn stop bar
- Tree at southeast corner obstructs sight distance
- No intersection lighting
- There is an access driveway poorly located on the channelized east to south right-turn

- Extend stop line for right-turn movement for NB approach
- Sharpen right-turn channelization to slow right-turn speeds reducing pedestrian crash risk and crash severity
- Provide reflective paint, pavement markers, and delineators to make channelizing island more visible
- Provide wider shoulders with level surfacing and vegetation trimmed
- Pull north to west left-turn stop bar back to minimize chance for west to south encroachment
- Trim tree to improve intersection sight distance
- Provide intersection lighting
- Relocate private access to either upstream on NM 313 or downstream on NM 315 out of the channelized area

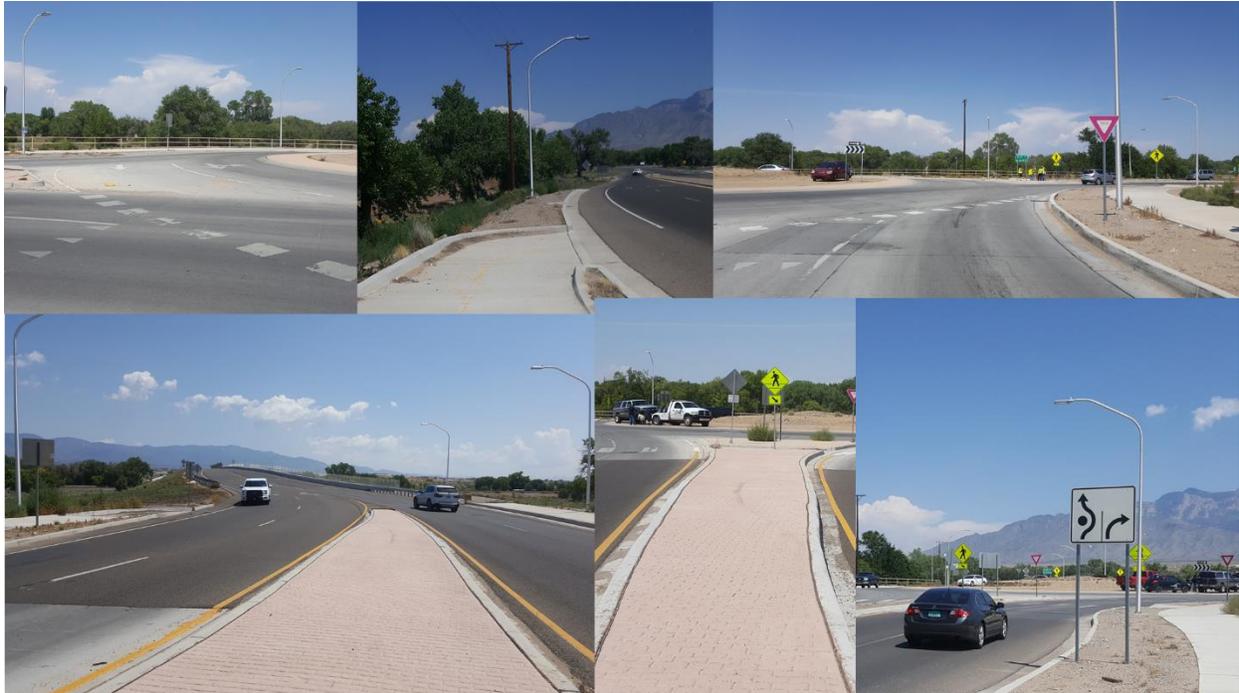
Roy Ave & NM 313 Pueblo of Sandia Village

- The west to south path through the roundabout allow greater speeds than are intended for this type of traffic control where the goal is to slow vehicle speeds

- It was mentioned that trucks have been taking the circulatory road at too great of a speed and overturning
 - A Pueblo representative mentioned that this has happened on at least three occasion within the past few years

- WB Approach Lane Use Striping is confusing
 - The approach striping says the outside lane is for through traffic only and inside lane is for left-turns only; however circulatory roadway striping immediately downstream from WB approach allows both lanes to go through; furthermore downstream striping in the circulatory roadway downstream of the west leg departure encourages both lanes to continue as left-turns

- The bicycle lane exits prior to entering the circulatory roadway are constructed at right-angles to the roadway making it difficult for bicycle to safely exit the roadway

- Sidewalk not continuous in all directions
- Pueblo representative at the field visit mentioned that many motorists are still confused on how to use the roundabout

- Look at adjusting EB approach entrance and SB exit curvature to introduce greater deflection, which in turn would reduce speeds
- Striping and signing on the westbound approach should be consistent with circulatory roadway striping
- If current WB lane utilization is to remain, the outside lane in the circulatory roadway could be eliminated just upstream of the EB approach to minimize driver confusion
- The bicycle lane exits could be reconstructed at an angle that will better facilitate exiting while still reducing exiting speed for to increase safety for pedestrians that share the sidewalk
- Increase education and public outreach on how to drive through a roundabout controlled intersection

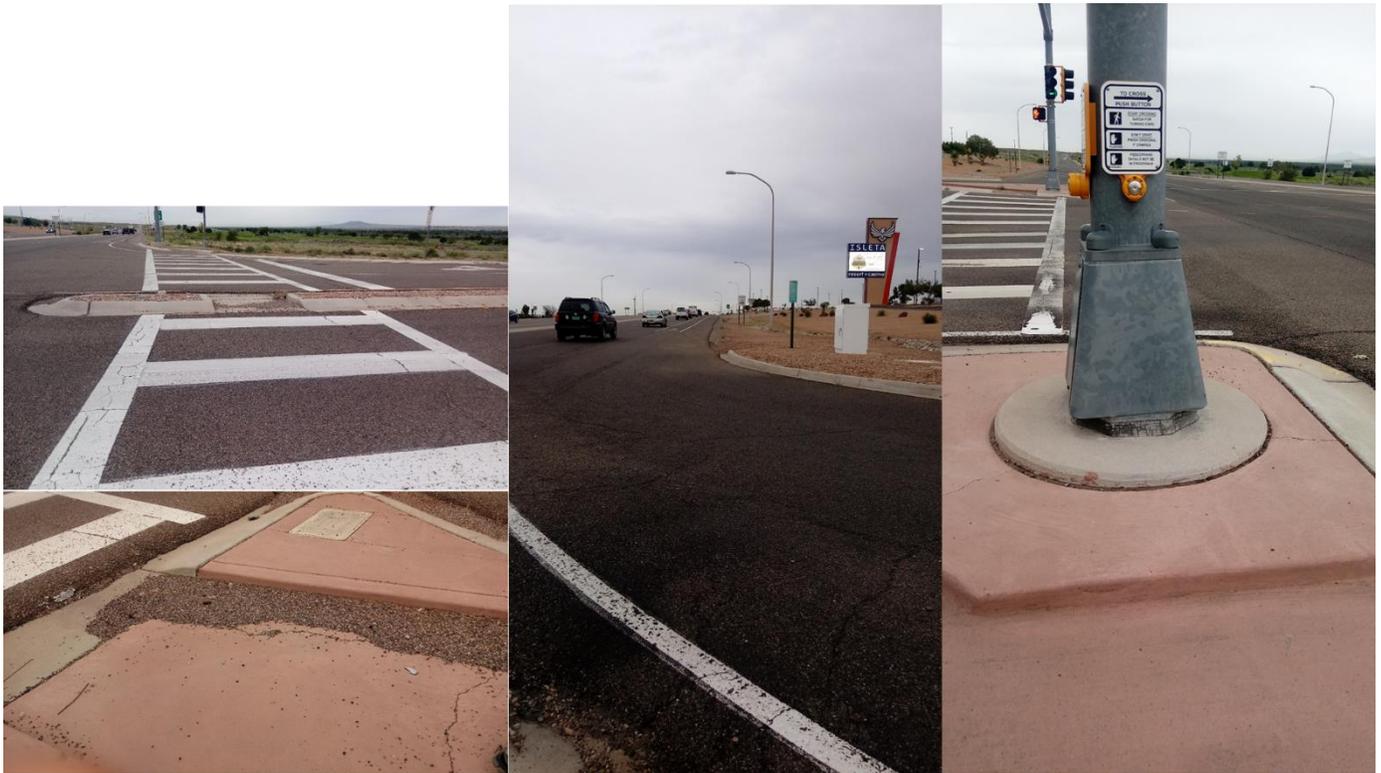
NM 47 and Isleta Casino

- Push buttons are not accessible
- 4 red light running while there SB Left one/ NB Left
- Required Case F Site Distance per AASHTO Green Book may not be accommodated between SB dual left and NB single left for permitted left-turns

- ADA ramps appear not to be compliant (I.e. Lack of tactile surfaces and appropriate slopes and landing areas.
- Debris in “accessible” areas
- Channelized right-turn from the Casino Entrance is very sweeping encouraging higher speed right-turn movements increasing pedestrian crash risks

- Pedestrian count down indication was not working on west side of intersection
- There is a lack of pedestrian connectivity as there are no sidewalks beyond the pedestrian ramps

- Green ball indication was out WB approach
- Pedestrian timing on recall could make for excessive timing delay for vehicles
- Observed speeds appeared to be greater than the speed limit

- There were no yield signs or pedestrian crossing signs at channelized right-turns in or out of the Casino Entrance
- No acceleration lanes for right-turn s from the Isleta Casino to NM 47

- Bring all pedestrian facilities into ADA/PROWAG compliance
- Fix signal and pedestrian signal indications
- Depending on sight distance analysis, eliminate north to west permitted left-turn phase
- Add yield and pedestrian warning signage at channelized right-turns
- Could look at advanced detection to provide dilemma zone protection to reduce red-light running and angle crashes
- Channelized right-turns could be sharpened to encourage slower maneuvers and thus reduce pedestrian crash risks
- Remove pedestrian recall
- Add appropriate length acceleration lanes for right-turns from Casino approaches

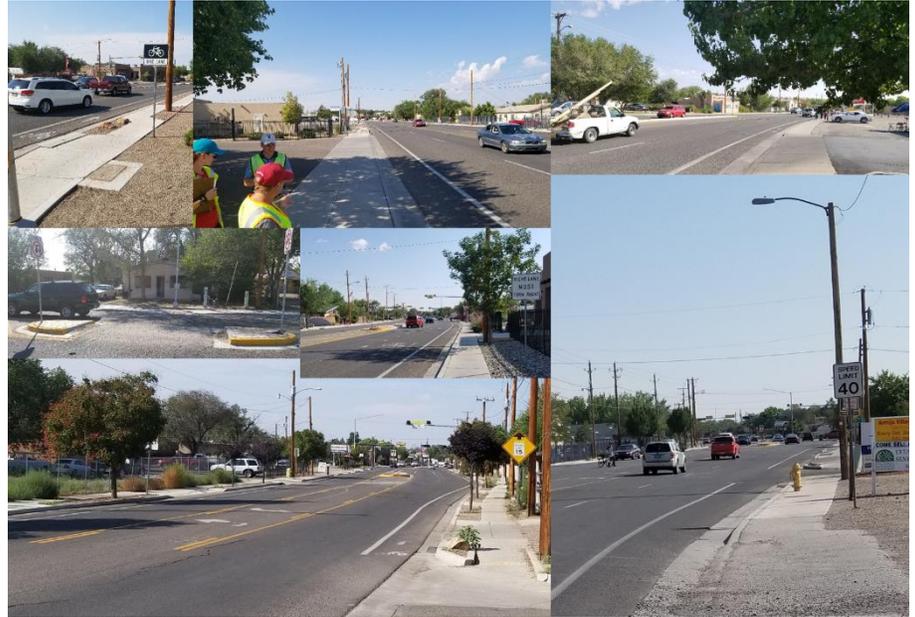
Corridor Field Visit: Goff/Isleta from Bridge to Gun Club

- Poor access management along this roadway with closely spaced and redundant full movement driveways
- Large sections of this roadway have two-way left-turn lanes which FHWA and HSM has shown to have greater crash rates than raised median roadways

- It was observed that many vehicles did not know how to negotiate this form of traffic control
- It appears that in the past an accessibility project was completed along this corridor improving sidewalk-scape, adding pedestrian button extensions, and ADA compliant ramps and tactile strips

- Bike lanes are present along this corridor and may be slightly narrow by today's standard but there appears to be no room to widen
- Speed limits were observed to be 40 MPH which might be a little high for a three lane cross-section and bicycle lanes with no buffers

- There was a median refuge observed just south of Vito Romero with no identified crosswalk or pedestrian crossing sign

- A reevaluation of access management should be completed for this corridor identifying redundant driveways, driveways to closely spaced, narrowing of driveways that are too wide and opportunities for driveways to be combine or moved to the side street
- Raised medians for all sections with two-way left-turn lanes should be considered and partial and full movement access points should be identified through the development of an access management plan
 - Raised medians will also increase the opportunity to provide pedestrian median refuges throughout the corridor
- A new education effort, initially focused in the community, should be implemented to educate drivers on how pedestrian hybrid beacons operate
- A speed study should be completed for this corridor as 40 MPH seems a little high for this type of corridor
