FIELD VISITS in the AMPA for the Regional Transportation Safety Action Plan (RTSAP)

SHOWCASE PROJECTS: INTERSECTIONS AND CORRIDORS

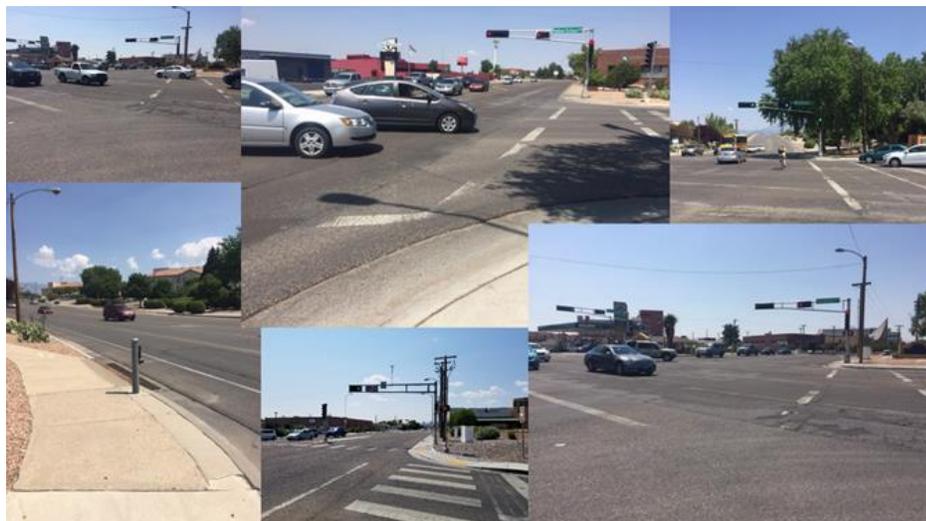
Indian School and University

- Indian school is identified as a bicycle route
- The NE and SW corners are very sweeping and could create more conflicts with right turners and bicyclists
- Bicycle lanes are too narrow for today's standards
- The intersection is not up to ADA/PROWAG standards
- There are some bike buttons available; although they are not identified very well
- Noted permitted left-turn conflicts with pedestrians in crosswalk
- Severe skew present which can reduce sight distance and increase crashes
- Closely spaced access driveways, especially on the west leg disrupts intersection operations

- Since Indian School is a bicycle route, bicycle detection and minimum green adjustment makes sense
- Widen bicycle lanes to current standard width of 5 feet
- Bring sidewalk, ramps and pedestrian buttons up to ADA/PROWAG standards
- Deploy flashing yellow arrows for protected-permitted left-turn phases to eliminate permitted left-turn movements against pedestrians in crosswalks
- Review access management driveways that could be combined or moved further away from the signalized intersection

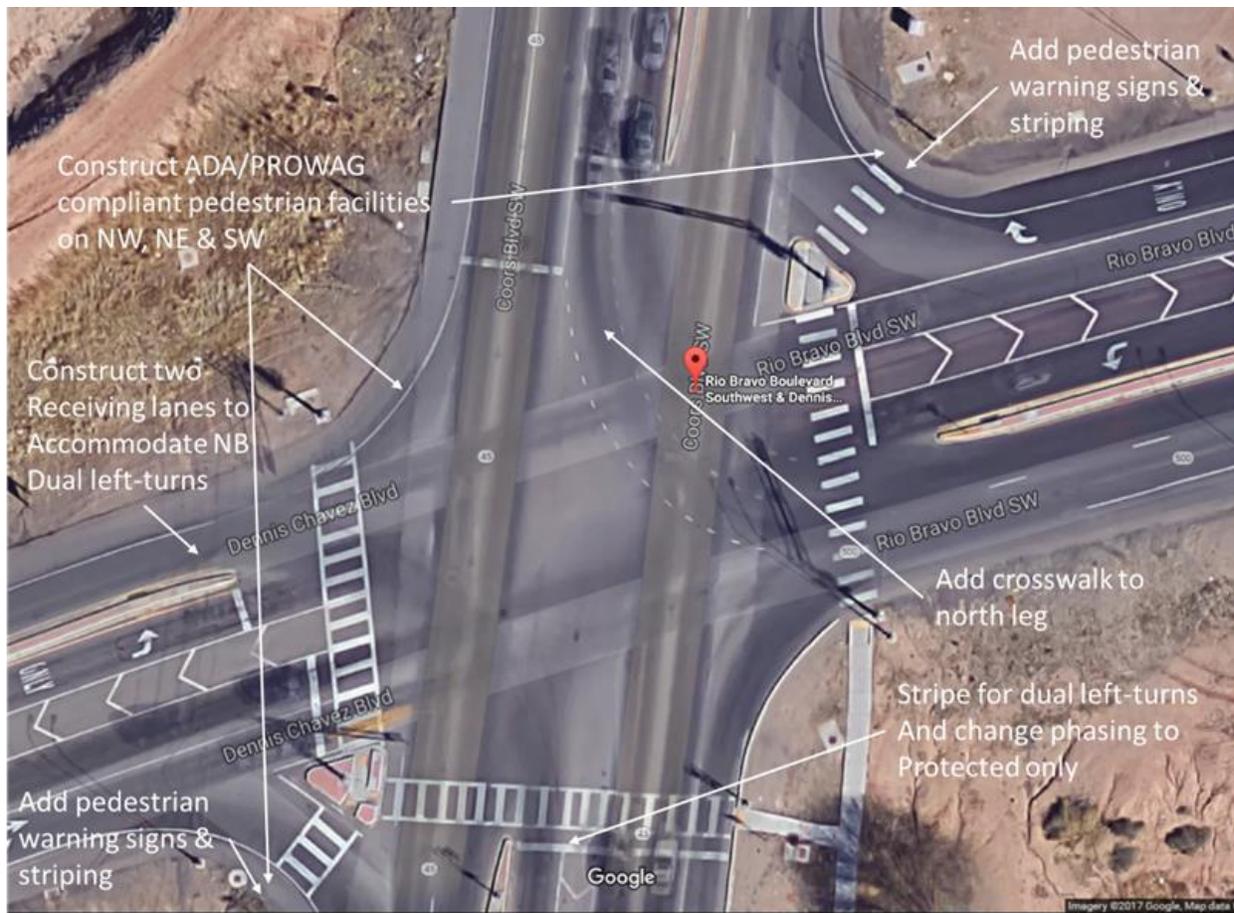
Rio Bravo Blvd & Coors Blvd

- Significant skew at all approaches
- There is minimal pedestrian connectivity and current facilities are not ADA/PROWAG compliant
- It was noted that northbound left-turn queues were backing well into the through lanes
- Very little convenient access to existing transit stops
- Case F sight distance requirements for northbound permitted left-turn lanes may not be satisfied
- Sight distance east-west is also limited by approach grades
- There was a pedestrian button and indication on the north leg but no crosswalk
- No pedestrian warning sign for both channelized right-turns

- Pedestrian facilities that are in compliance with ADA/PROWAG
- Ideally north to west left-turns should go to dual lanes as there is width; however in addition the west departure leg also needs to be reconstructed to receive two lanes
 - Once dual left-turn lanes are constructed this movement would go to protected only mitigating the site distance issue
- Should do an east-west case F sight distance study to make sure appropriate sight distance are provided for east-west permitted left-turns
- Either a crosswalk facilities need to be provided on the north leg or pedestrian signal phasing should be removed
- Pedestrian warning signs and striping should be provided at both channelized right-turns

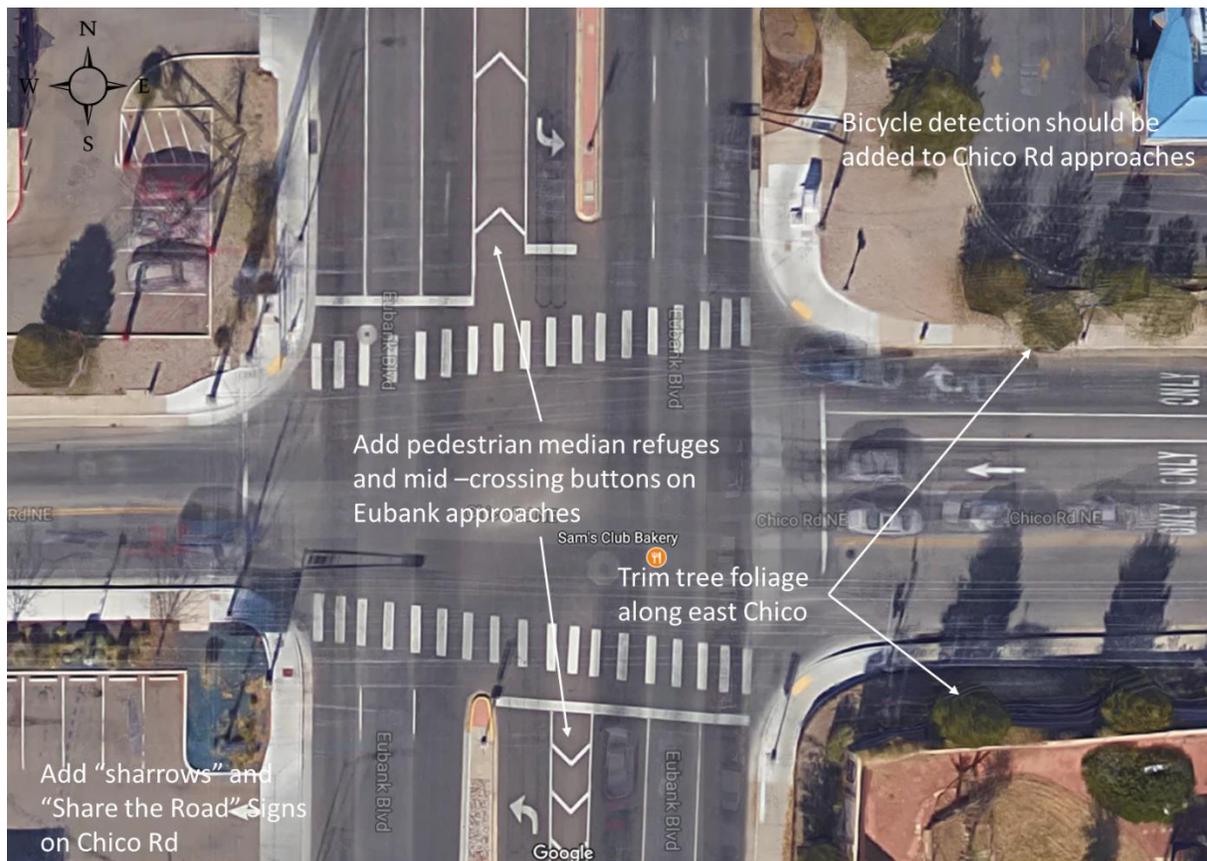
Eubank & Chico

- Pedestrian phase crossing San Mateo felt short
- Vehicles ignored right-turn pocket striping and driving in bicycle lane
- Chico at this location currently is a bike route
- Minimal signage indicating this was observed. Also there was no share the road signs to alert drivers
- There does not appear to be any bicycle detection nor does the minimum green time appear to accommodate a bicycle crossing of Eubank
- Long pedestrian crossing distances across Eubank.
- People speeding/running red lights
- Some low hanging trees potentially obstructing intersection sight lines
- Angled crosswalks lengthen the crossing width considerably/ big intersection
- Full movement access to shopping center on east leg is very close to the intersection, which not only interferes with the operation of the signal but also present cyclist with increase potential vehicle/bicycle conflicts

- Right-turn pocket striping could be enhanced with reflective delineators
- Consideration should be given to keeping the east leg of Chico consistently a bike-shared condition rather than having a bike lane for only 300 feet at the intersection, especially considering a shared condition also exists on the west departure leg as well

- Trim trees along Chico Rd to maximize sight lines
- An access management study should be completed to review appropriate driveway spacing and driveway movements

- Review pedestrian crossing lengths and adjust “Walk” and “Flashing Don’t Walk” times per 2009 MUTCD or later
- Right-turn pocket striping could be enhanced with reflective delineators

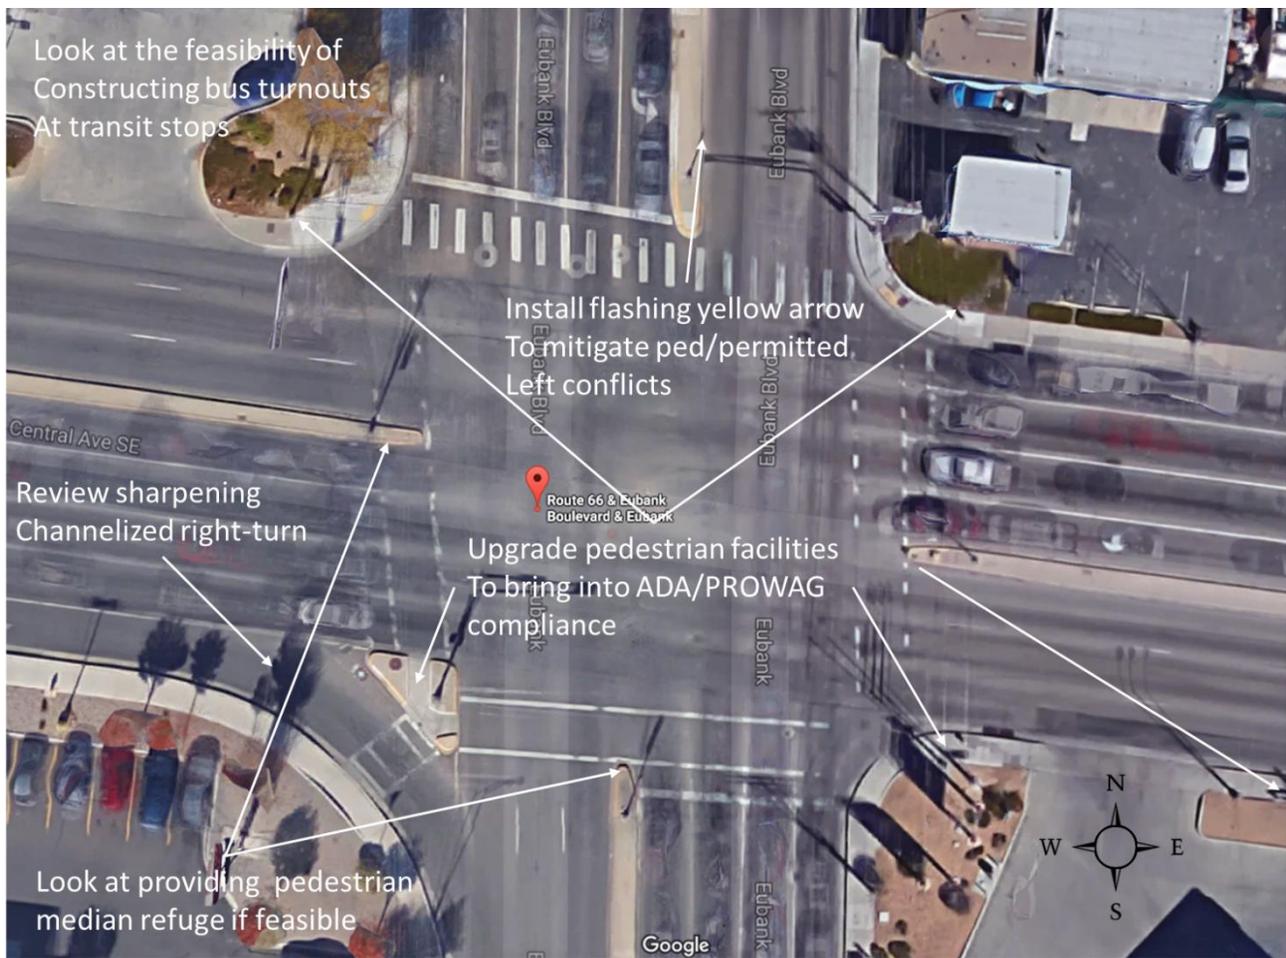
Eubank & Central

- Quite a lot of people walking as well as people on bikes
- Intersection corners are not ADA/PROWAG compliant (ie. accessible button and sidewalk obstructions, and some tactile surfaces missing on south corners)
- Speeds in excess of 50 mph were observed in the field
- Central pavement in poor condition
- Some ped crossing phase times felt short
- Many pedestrians were observed not crossing at the intersection but just upstream/downstream
- SW corner pedestrian indication was obstructed
- There are transit stops on all four departure legs of the intersection with no bus turnout
- West leg median nose obstructs crosswalk path

- An effort should be made to relocate obstructions out of the sidewalks
 - These include bus-stop structures and benches, newspaper vending machines, poles and controllers to name a few

- Consideration to employing bus-turnouts at transit stops might reduce the potential for sideswipe crashes and increase capacity

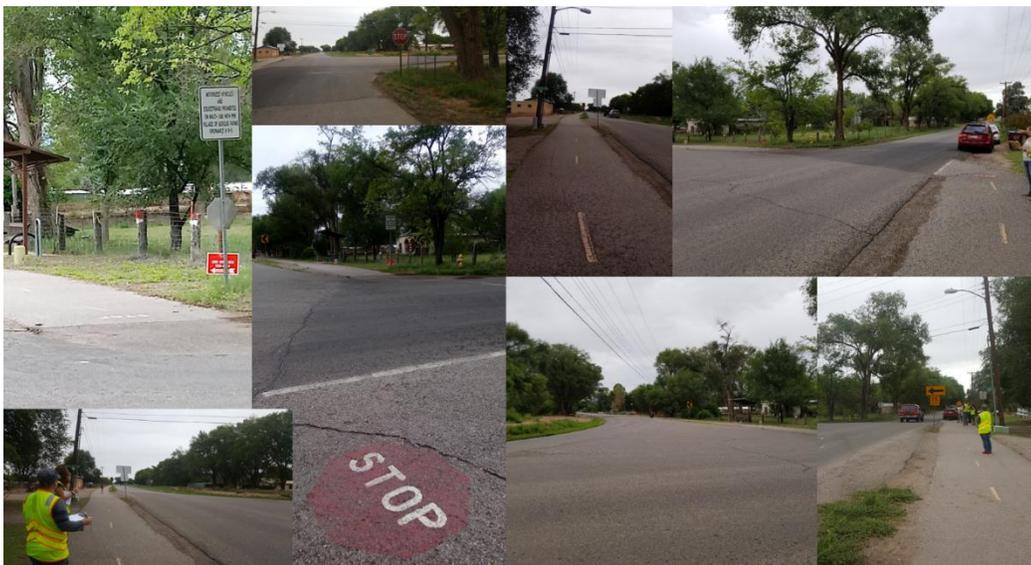
Bosque Loop and McNew Road

- Resident saw near miss crashed with bicycles

- Could use Painted or Reflective Object Markers Reducing Drivable Area
- Eliminate high speed direct SB movement from Bosque Loop to McNew Road
- No Definition of Appropriate Turning Movements
- Large un marked pavement width is present confusing desired vehicle pathing and encouraging high-speed SB vehicles
- Move or clear foliage so stop sign on McNew can be seen

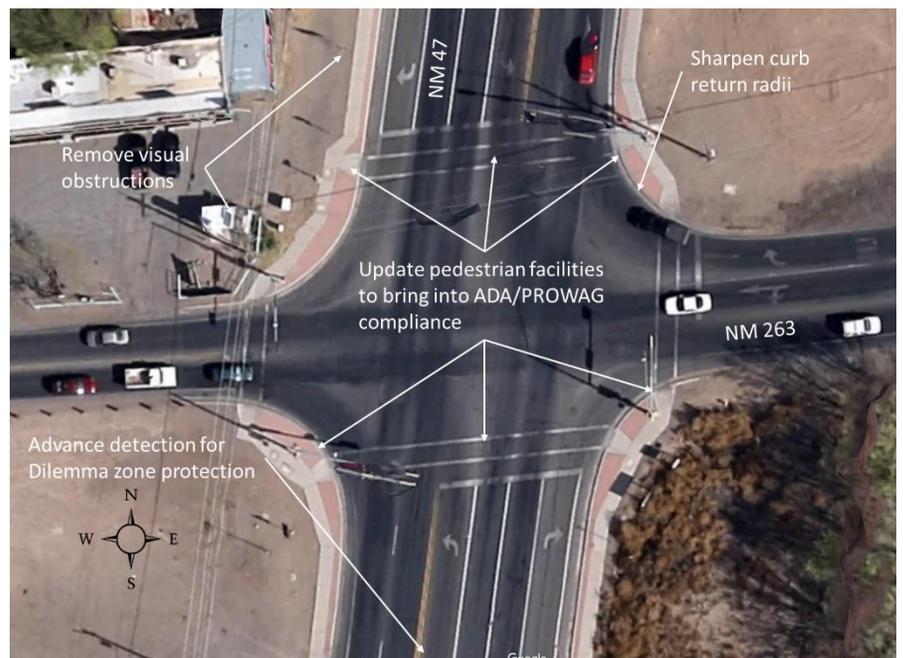
- Several pedestrian facility issues including non-ADA/PROWAG compliance, signal indication missing or not working, and crosswalks worn
- Poor line of sight for eastbound approach especially for eastbound right-turns and left-turns.
- Very large curb return radii
- Observed 5 red light runners (2 westbound NM263,1 southbound NM 47, 2 northbound NM47)
- Saw a significant proportion heavy trucks in traffic demands, which probably explains the large curb return radii
- There was a memorial cross indicating fatality on NE corner of the intersection
- Observed many right-turn on red movements not yielding to pedestrians
- No Lighting present at intersection

- Upgrade pedestrian facilities to include more modern crosswalk striping, tactile surfaces, new ramps, and audio/vibro-tactile buttons
- Potential candidate for leading pedestrian interval depending on pedestrian demands
- Sharpen curb return radii while still allowing traversal of trucks
- Review yellow and all-red transitions times and adjust based on clearance distances and the latest practice
- Advance detection on NM 47 to reduce dilemma zone and potential for rear end and angle crashes
- Observed many right-turn on red movements not yielding to pedestrians
- No Lighting present at intersection

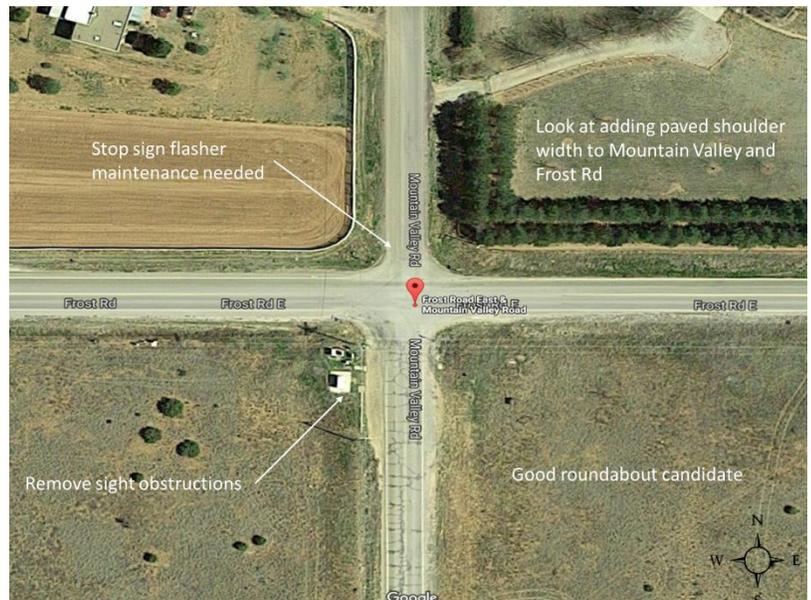
Frost Rd and Mountain Valley

- South bound detectors and flashers on stop sign are not working properly
- This intersection was planned to go to a two-way stop due to 2009 MUTCD requirements for a four-way stop
 - The public was against this removal due to area speeding and the four-way stop remains
- Some line of sight issues with east bound Frost looking north – a lot of utility boxes, etc. (Especially on southwest corner)
- There are grade issues north bound on Mountain Valley that limit sight distance
 - There is an advanced warning sign present indicating a stop sign ahead
- There have been local complaints of speeding on all approaches

- Maintenance needed on stop sign flasher detector
- Since speeding has been identified as an issue by the local populace, roundabout control would be a good fit for this intersection
- Sight distance obstructions should be relocated
- Might consider adding shoulder widths to these roadways on next project to accommodate pedestrians and bicycles

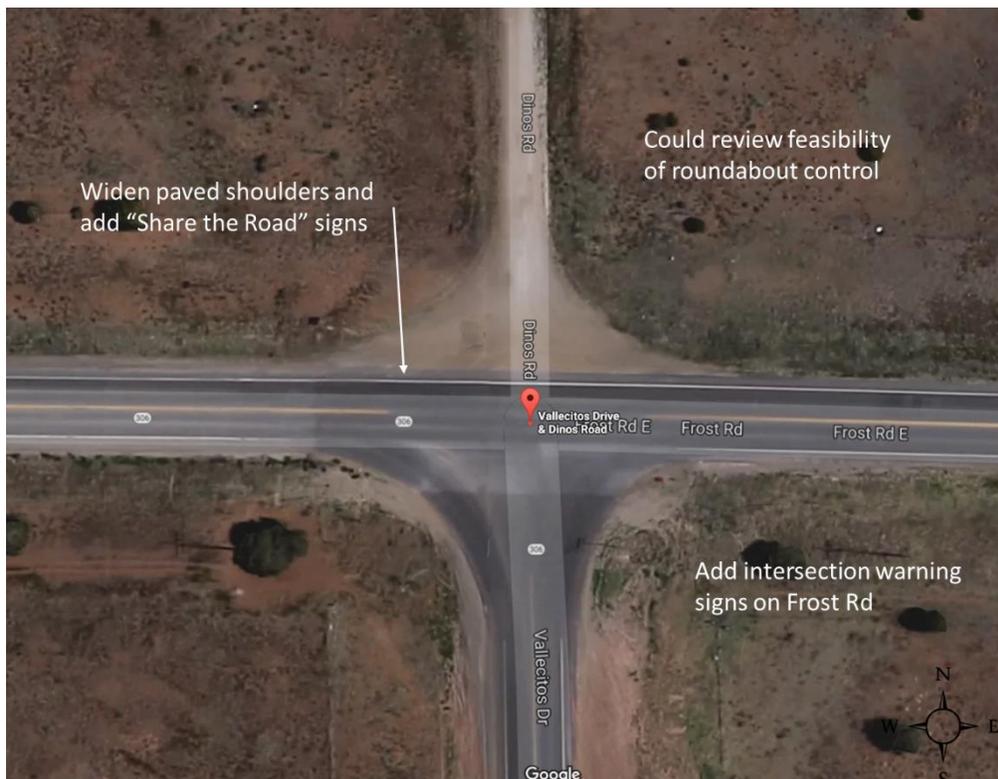
Frost Rd and Vallecitos Rd

- Speeding seems to be an issue on Frost Road
- Speed limits appear to change along Frost Road
- Bike routes are identified on Frost Road, however existing shoulders are narrow and there are no “Share the Road” signs
- No stop line present at south leg stop sign

- With speeding being an issue along Frost, more consistency in speed limits might help with compliance
- Roundabout control is a good mitigation for speeding issues and significantly reduces crash severity
- With bicycle routes identified on Frost Road, an effort should be made to widen paved shoulders
- Add “share the Road” signs on Frost Road
- Could include intersection warning signs on Frost Road

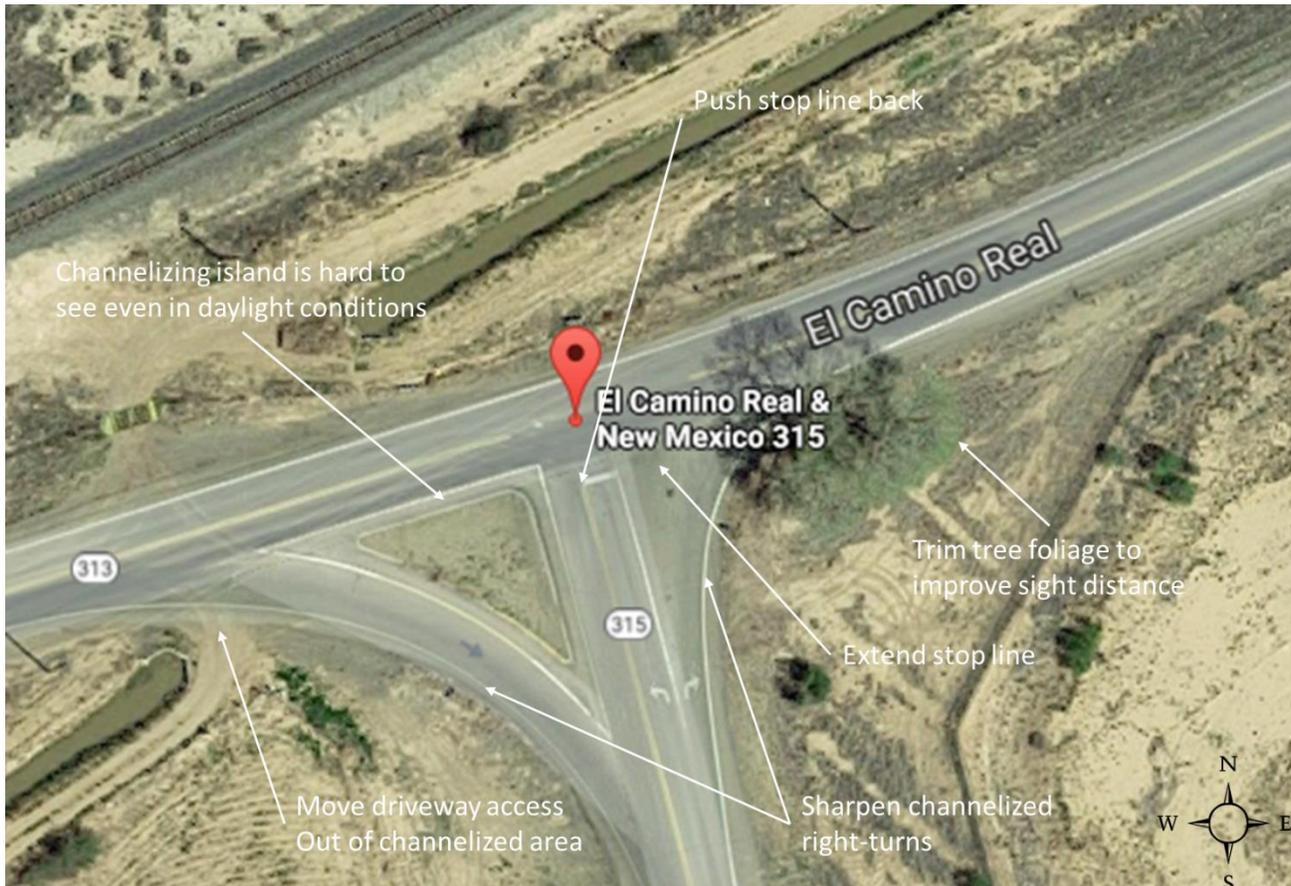
- No stop bar on north bound right-turn
- Sweeping turns on both sides encouraging higher speeds
- Large channelizing island is difficult to see
- No crossing marks or pedestrian facilities
- Shoulder condition poor for bikes/pedestrians including vegetation in way / poor edge condition and slim shoulder available
- WB left turning movement may cut across stop bar due to the location of the NB left-turn stop bar
- Tree at southeast corner obstructs sight distance
- No intersection lighting
- There is an access driveway poorly located on the channelized east to south right-turn

- Extend stop line for right-turn movement for NB approach
- Sharpen right-turn channelization to slow right-turn speeds reducing pedestrian crash risk and crash severity
- Provide reflective paint, pavement markers, and delineators to make channelizing island more visible
- Provide wider shoulders with level surfacing and vegetation trimmed
- Pull north to west left-turn stop bar back to minimize chance for west to south encroachment
- Trim tree to improve intersection sight distance
- Provide intersection lighting
- Relocate private access to either upstream on NM 313 or downstream on NM 315 out of the channelized area

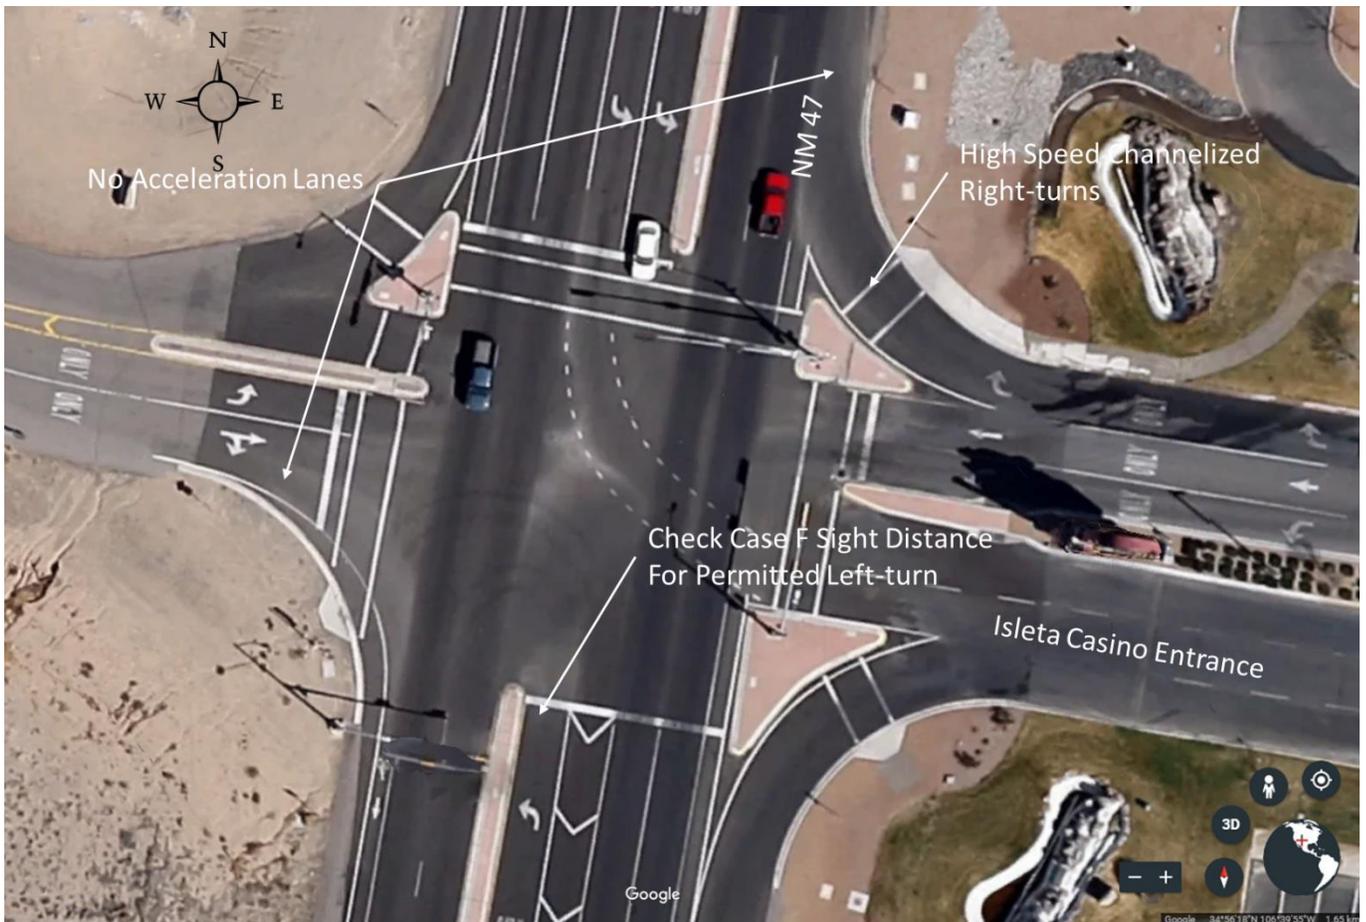
NM 47 and Isleta Casino

- Green ball indication was out WB approach
- Pedestrian timing on recall could make for excessive timing delay for vehicles
- Observed speeds appeared to be greater than the speed limit

- Bring all pedestrian facilities into ADA/PROWAG compliance
- Fix signal and pedestrian signal indications
- Depending on sight distance analysis, eliminate north to west permitted left-turn phase
- Add yield and pedestrian warning signage at channelized right-turns
- Could look at advanced detection to provide dilemma zone protection to reduce red-light running and angle crashes
- Channelized right-turns could be sharpened to encourage slower maneuvers and thus reduce pedestrian crash risks
- Remove pedestrian recall
- Add appropriate length acceleration lanes for right-turns from Casino approaches
